Manhole Inspection Summary

Manhole # S45U__029MH

Insp Date: **3/6/08 3:14 PM**

Location Address: **1200 Cooksie Street**

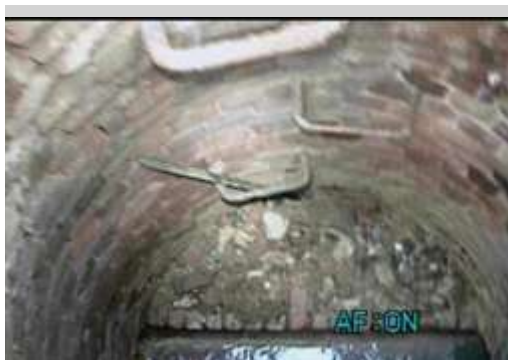
Defect 3

Count: **3** Missing: **0** ☒ **Corroded**

corroded steps

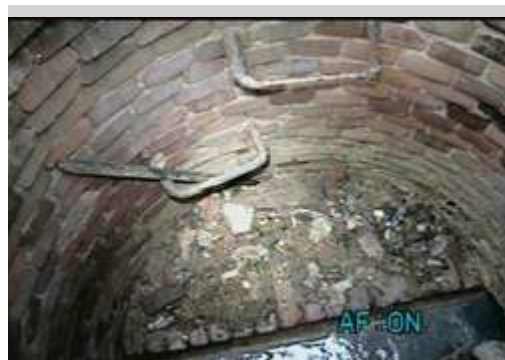
Defect 2

bench debris

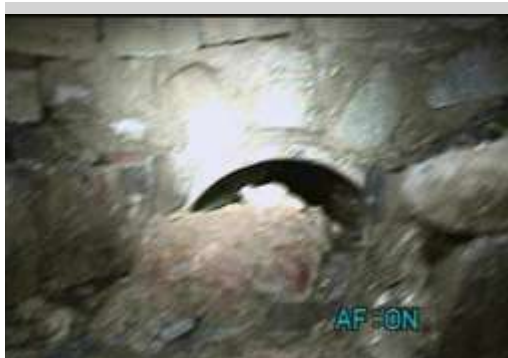
Defect 1

channel debris

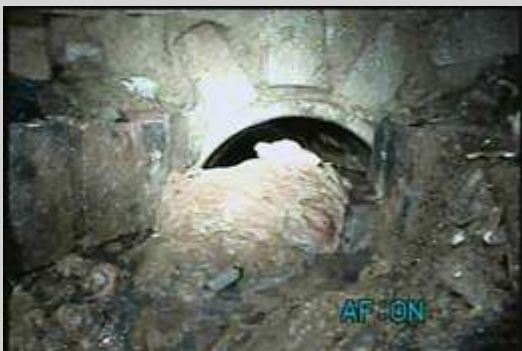
3 O'Clock Inflow

Pipe Height: (in.) Direct
Pipe Material: **Clay** ☐ Pipe Lined
Invert Depth: **6.75** (ft.) Flow Characteristics: **Slow**
Deposits: ☐ None ☐ Mud ☒ **Sludge** ☐ Debris ☐ Grease
Silt Depth: **6** (in.) Deposits Extent: **Heavy**
Infiltration: **None** Pipe Seal Cond: **Unknown**

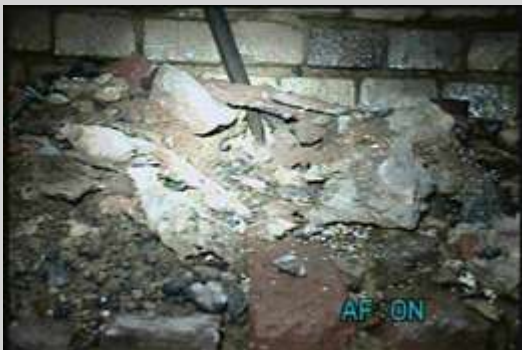
9 O'Clock Inflow

Deposits: ☐ None ☐ Mud ☐ Sludge ☒ **Debris** ☐ Grease

Silt Depth: **8** (in.) Deposits Extent: **Heavy**

Connects To: **Stub connection / abandoned**
